Inspection Report

Minerals Regulatory Program

Mine Name: Torry Buff	Permit Number: S550012
Operator Name: John Young	Inspection Date: May 2, 2012
Inspector(s): Wayne Western	Time: 4:00 – 5:00 pm
Other Participants: none	Mine Status: ACT

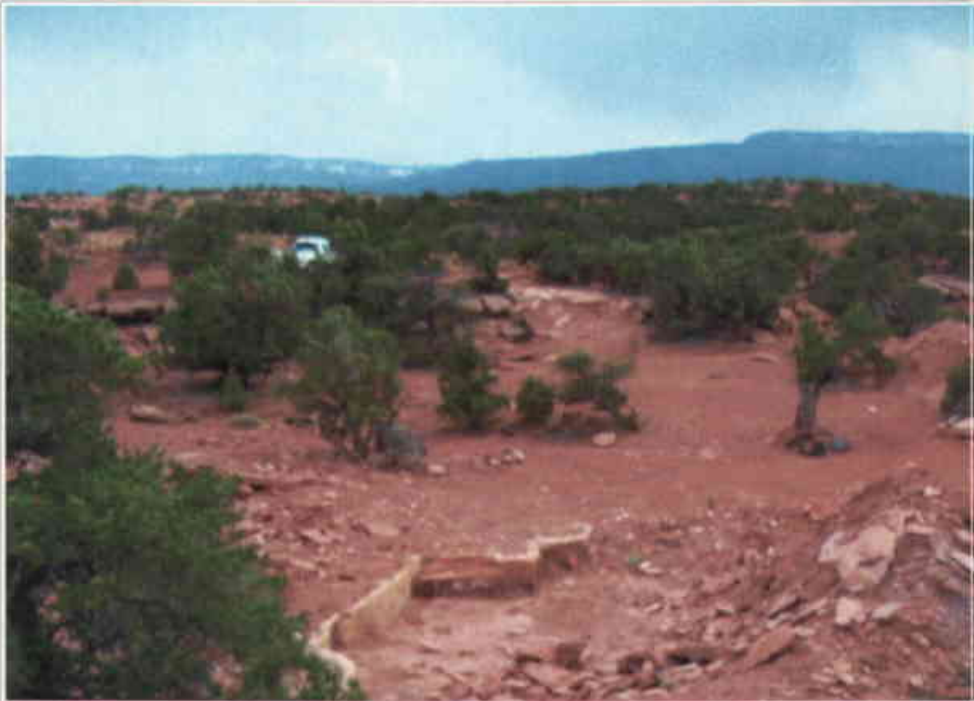
Two piles of material on lower left corner of screen the other middle left edge.

The Division contacted John Blake with SITLA about the situation. SITLA and the Division agreed to contact the Permittee and give 30 days to reclaim. If reclamation is not completed except for seeding by the deadline then the Division will write a CO.

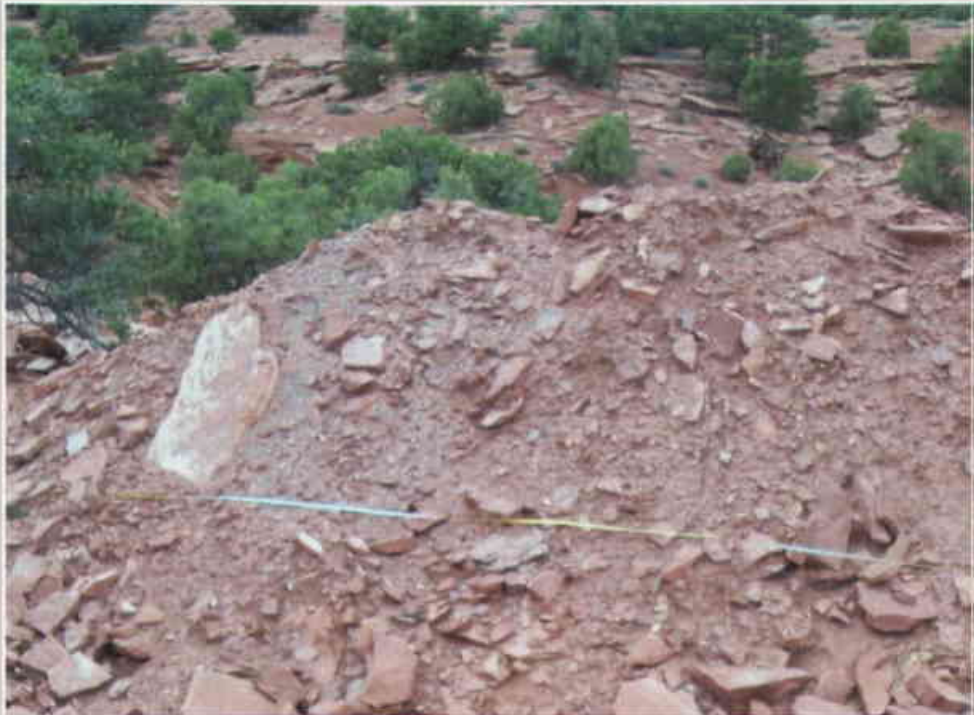
There are some pits on the site and some stockpiles on material. The Permittee should have placed the stockpiled material in the pits as part of reclamation. The largest pit is 37 feet long and the smaller is 12 feet long.

Close up of larger pile approximately 37 feet by 12 feet.

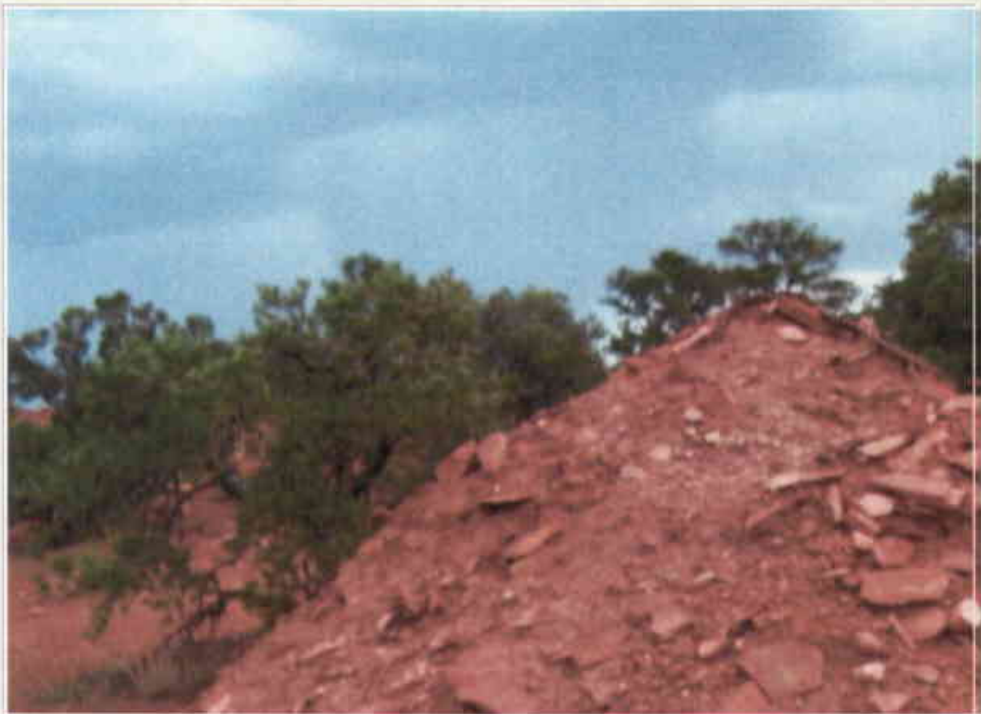
Close up of second pile

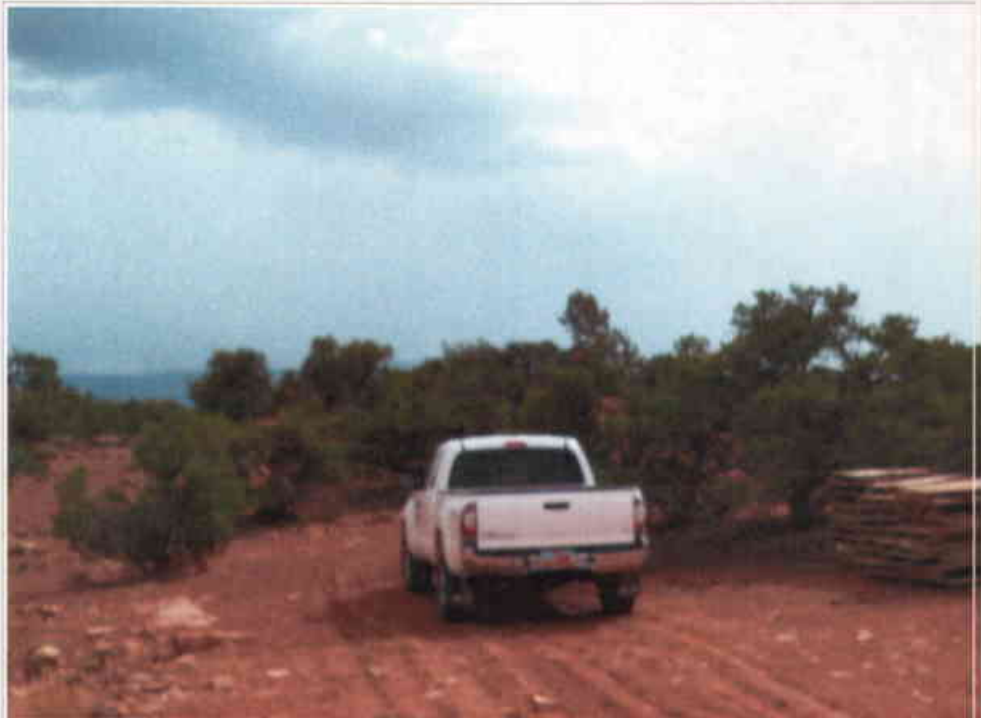
There are a large stack of pallets on site. In addition there are some stones that were placed on pallets.

Stack of pallets
